TOWN OF  
CLIFTON PARK  
ADA TRANSITION  
PLAN

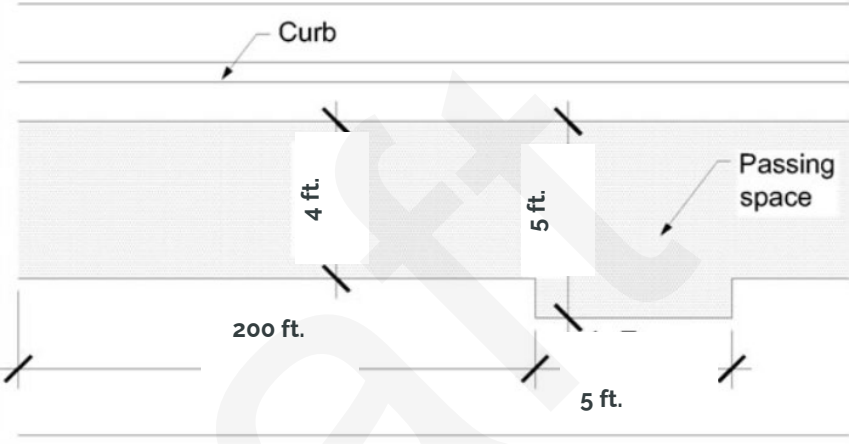
<p><i>Pedestrian Access Route/Pathway</i></p>

Pedestrian Access Routes (PAR) are walkways, or paths, for people to travel. The path must be a continuous width of at least 4ft. wide. If the clear width of the path is less than 5ft, then there must be a section that is at least 5ft at a maximum of every 200ft. This is referred to as a "Passing Space". The Surface of the path needs to be firm, stable, and slip resistant. Examples of commonly used materials are concrete, asphalt, and brick.

<p>The diagram illustrates a cross-section of a pedestrian access route. It shows a path with a minimum width of 4 feet. A 'Curb' is indicated on the left side. A 'Passing space' is shown as a section where the path width increases to 5 feet. This passing space is required at a maximum interval of 200 feet. The diagram also shows a 5-foot wide section of the path.</p>
<p><i>Grate in Pathway:</i></p> <p>If a grate is incorporated into a pathway, the holes in the grate should be no larger than ½ inch in diameter.</p>

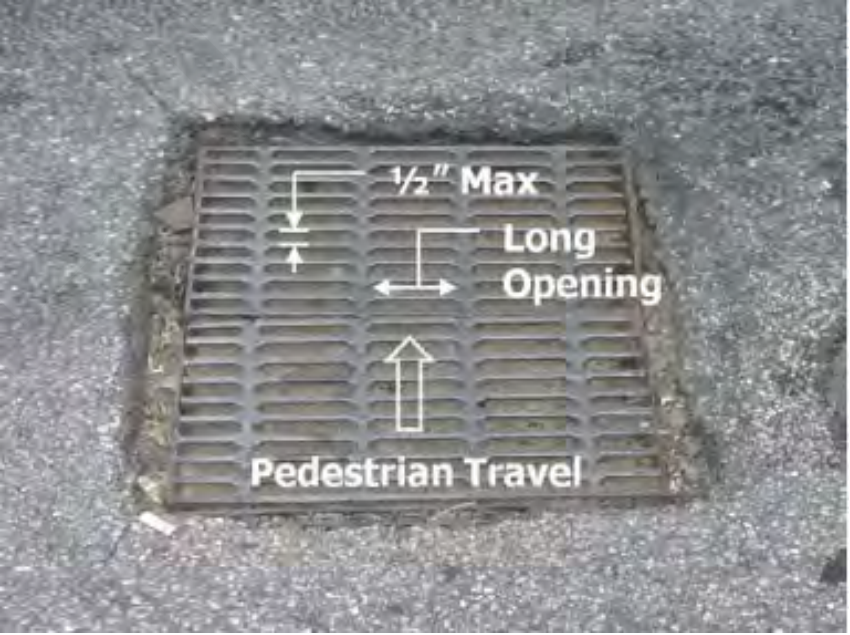
<p>The photograph shows a square grate set into a paved surface. Annotations include: '1/2" Max' with a vertical arrow pointing to the height of the grate's openings; 'Long Opening' with a horizontal arrow pointing to the length of the grate's openings; and 'Pedestrian Travel' with a white arrow pointing upwards through the grate.</p>

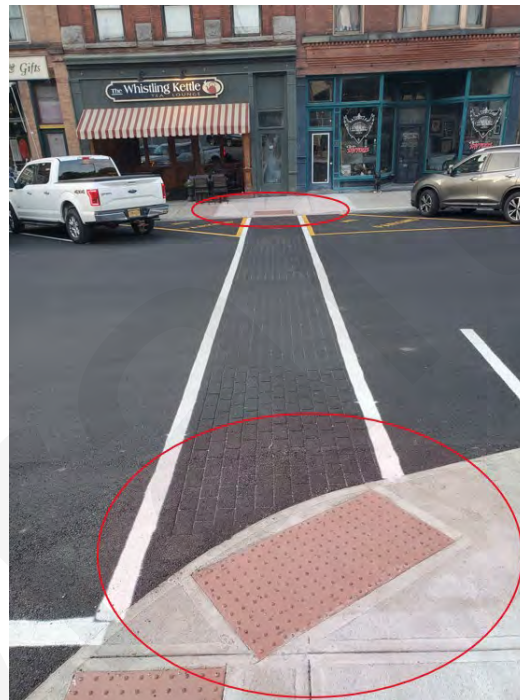
While often marked, it is not required. The location of a curb ramp on both sides' makes a complete pedestrian access route. If there is a curb ramp on one side and not the other, then the path is considered inaccessible.

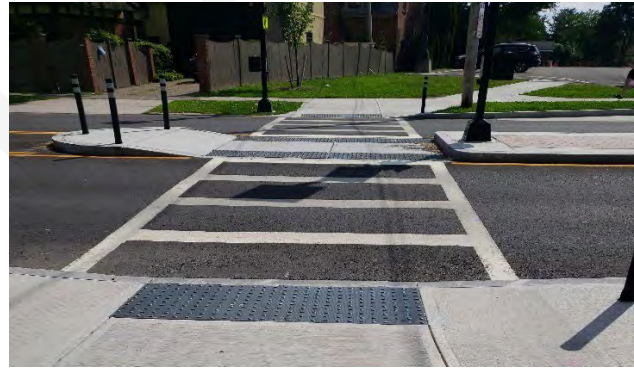
An area within an intersection where people wait for a break in traffic to safely cross the remainder of the intersection. Curb ramps in refuge islands must meet all the accessibility criteria of curb ramps not in refuge islands.

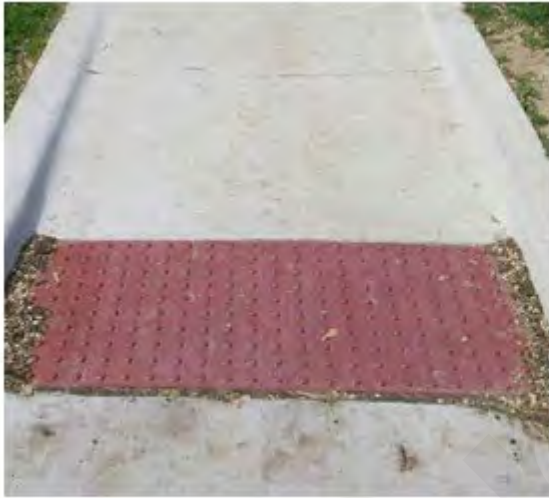
Truncated domes

**Truncated Domes:** Elevated, bubble-like domes on the surface of the DWS. The domes should have an approximate height of 0.2 (1/5<sup>th</sup>) inches. The domes should face the same direction as the sidewalk.

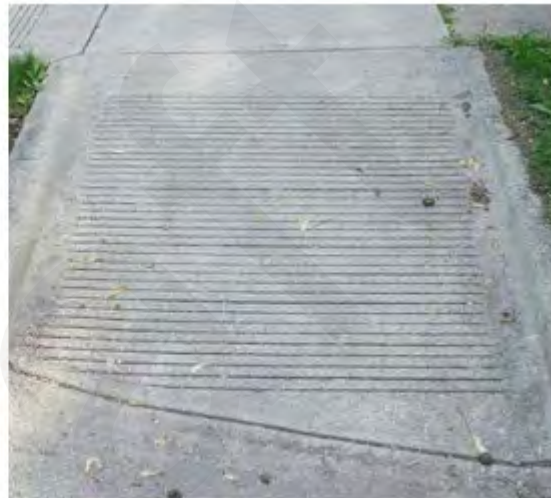
**Pavement Grooves:** Grooves cut into the existing concrete, facing the same direction as the sidewalk. Pavement grooves are common but are not recognized as an acceptable DWS type because they do not provide a visual contrast between the pavement and ramp.

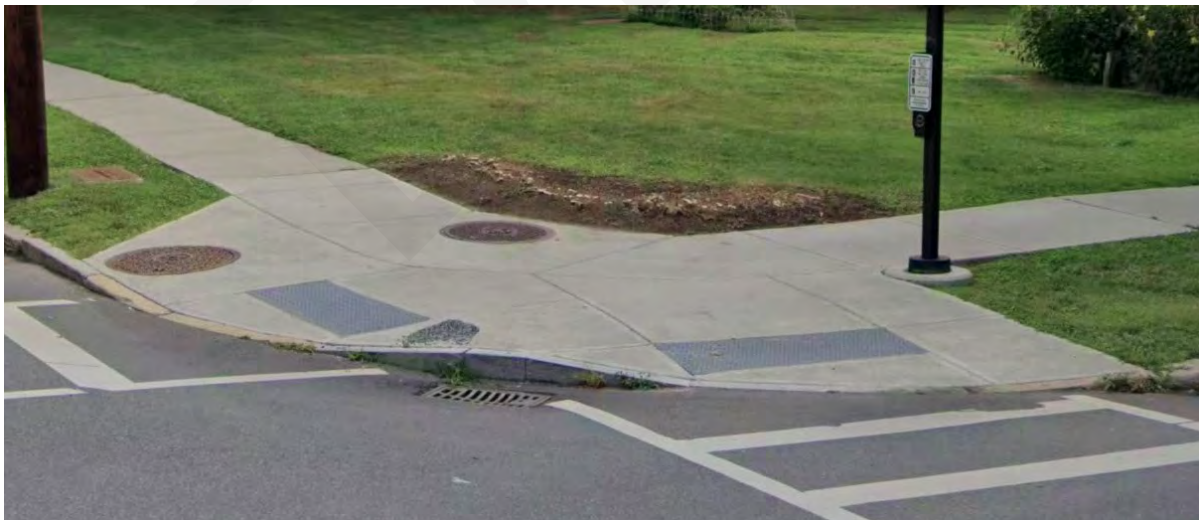
**Width:** The DWS should extend the full width of the curb ramp or sidewalk. The minimum width is 4 feet (48 inches).

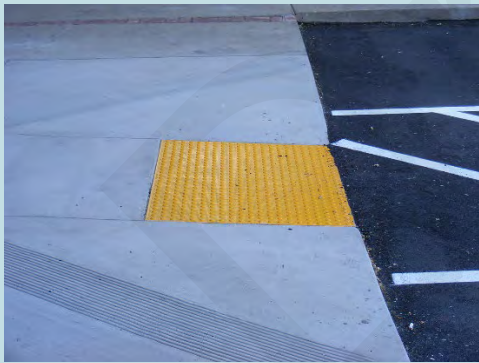
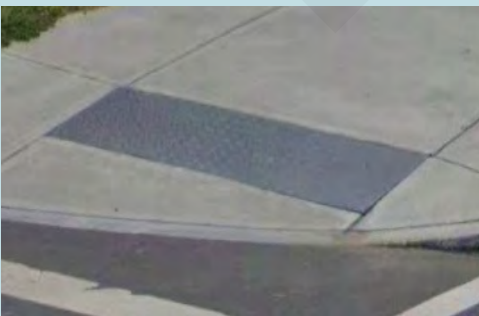
### DWS COLOR CONTRASTS FROM CURB RAMP

- The color should contrast from the sidewalk, it should at least be light-on-dark or dark-on-light.
- Best practices is to install a yellow DWS (as seen on bottom left image) as it is the most visible for the vision impaired, darker colors often appear as missing gaps in the sidewalk.

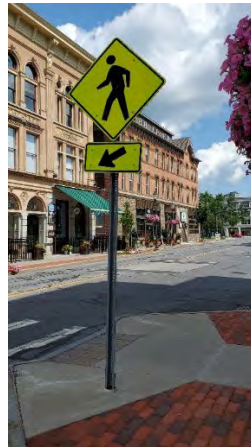
**Pedestrian Sign – Not pedestrian activated:** A sign marked for pedestrian crossing without a button to press. It may or may not have flashing lights.

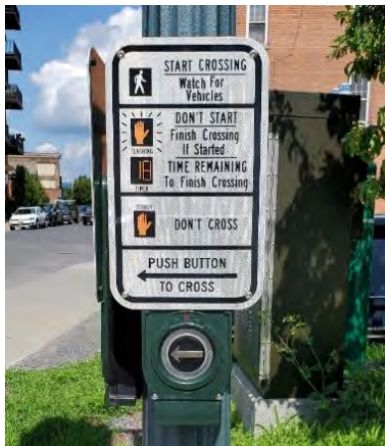
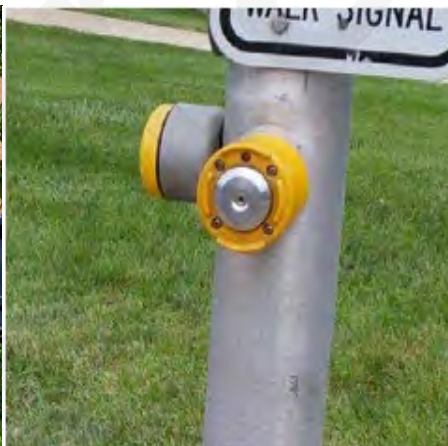
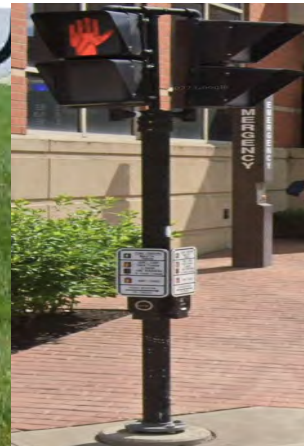
**Pedestrian Signal – Pedestrian activated:** A button pushed by the pedestrian, which activates a crossing signal. It may or may not have a flashing light.

### Features of the pedestrian crossing buttons:

**Visual:** Flashing lights, large/bold fonts and arrows are used.

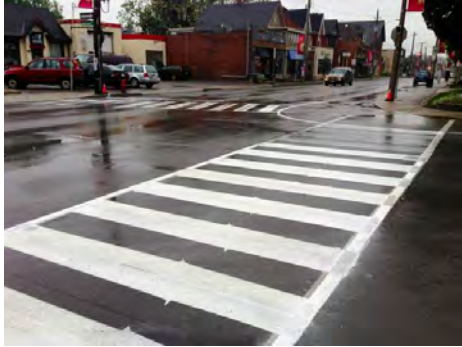
**Painted**

Crosswalk markings should be smooth and even with the road surface. The material of the crosswalk may differ from the typical pavement striping for aesthetic purposes. Common materials used, other than paint, are brick pavers, stamped concrete, or asphalt.

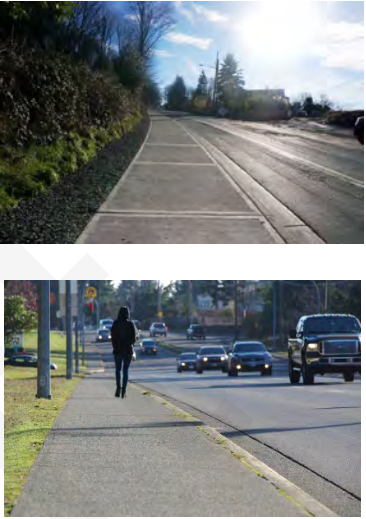
Rating	Condition	Reference Images
Fully Accessible	<ul style="list-style-type: none"> <li>• Sidewalk is new or in like-new condition.</li> <li>• Sidewalk is level, no cracks, no faults, no obstructions, and adequate width.</li> <li>• Sidewalk is at least 4 feet (48 inches) wide.</li> </ul>

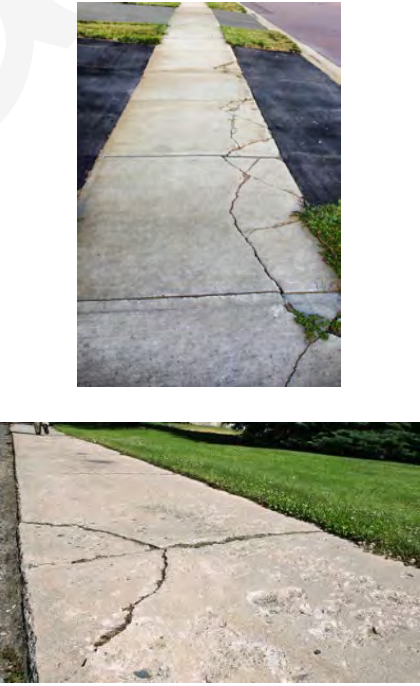
Mostly Accessible	<ul style="list-style-type: none"> <li>• Sidewalk is in almost new or good condition.</li> <li>• Sidewalk is level and may have minor cracks.</li> <li>• Sidewalk is at least 4 feet (48 inches) wide.</li> </ul>

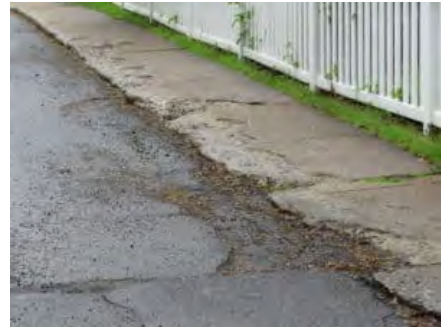
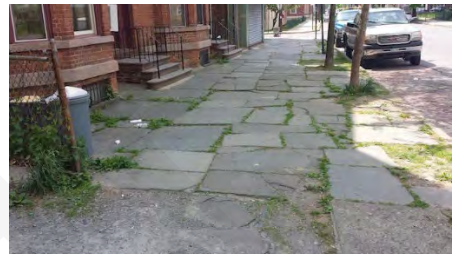
Partially  
Accessible

- Small patches of broken or chipped sidewalk, and a small buildup of dirt/debris, vegetation growing between panels or cracks.
- Sidewalk may have small vertical faults larger than  $\frac{1}{2}$  inch but could potentially be grind down/repaired.
- Large cracks are present.
- Sidewalk is less than 4 feet wide.

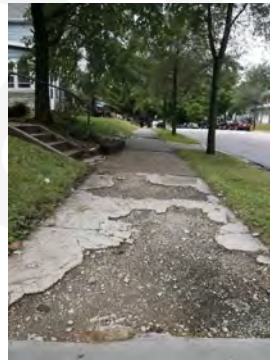
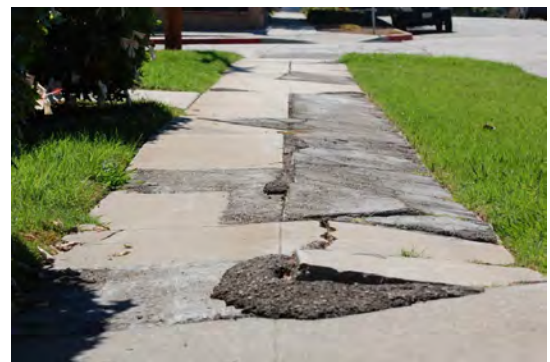
Not  
Accessible

- Sidewalk may have serious accumulation of dirt/debris, establishment of vegetation or other obstructions.
- Sidewalk is uneven from faulting (greater than  $\frac{1}{2}$  inch) that cannot be grind down/repaired and will require replacement.
- Sidewalk is less than 4 feet wide.
