Clifton Park Town Center Park Property Biological Survey Report

July 31, 2019

Prepared By:
Michael S. Batchner, M.S., A.I.C.P.
Ecologist and Environmental Planner
1907 Buskirk-West Hoosick Rd.
Buskirk, NY 12028

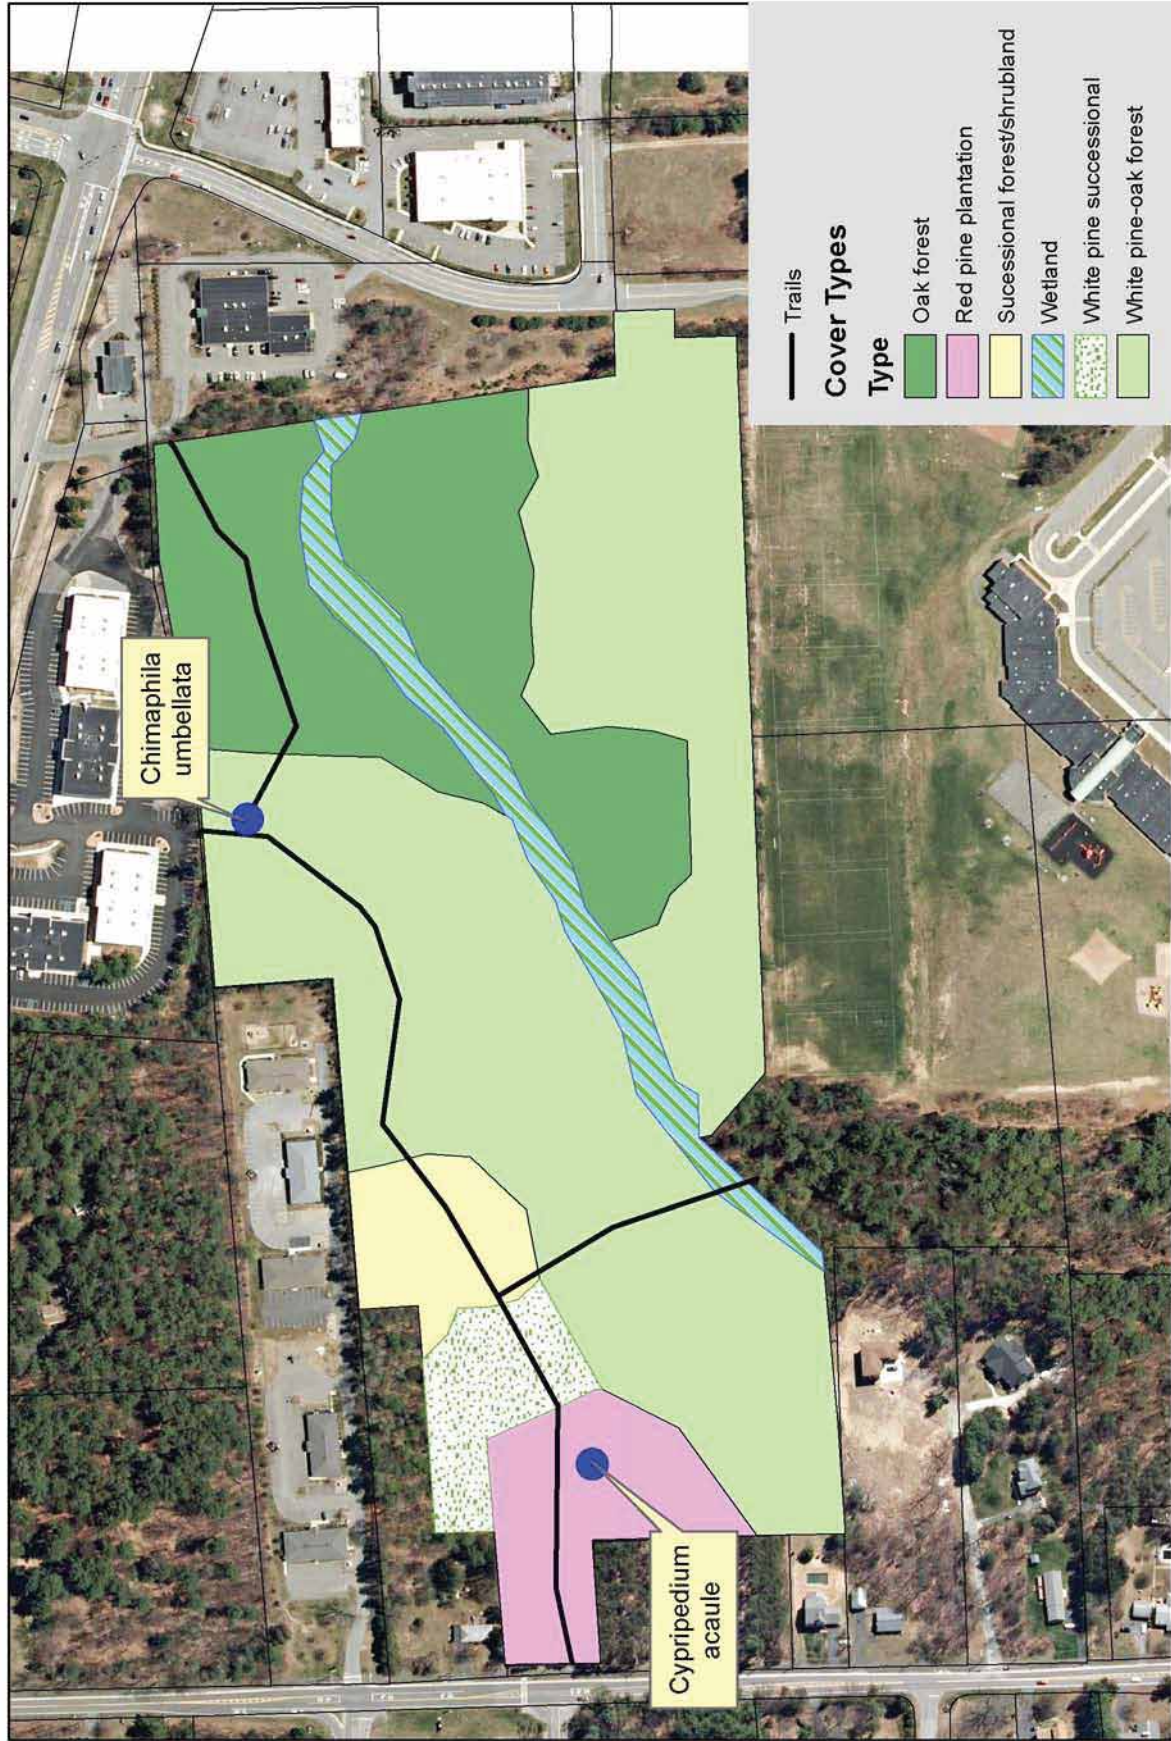
Map 1. Cover Types and Other Features

Red Pine Plantation (2.6 acres – Figures 3 and 4): This type is an obvious plantation of red pine (*Pinus resinosa*) as the trees are clearly in rows. White pine seedlings and saplings are coming in, but the ground layer is depauperate. However, there seems to be a difference between the plantation north of the east-west road and south of that road. South of the road, the plantation is dominated by red pine. The southern patch is almost totally red pine with very little growing underneath (Figure 3). That said, there is a small patch of pink lady's-slipper (*Cypripedium acaule*, Figure 4) in the approximate location I marked on Map 1. The New York Natural Heritage Program would describe this as a Pine Plantation.

Winterberry and turtlehead would most likely be in the wetland, but I did not observe either. I did see what could have been baneberry, but it was not identifiable during that visit. I indicated the location for Pipsissewa on Map 1.

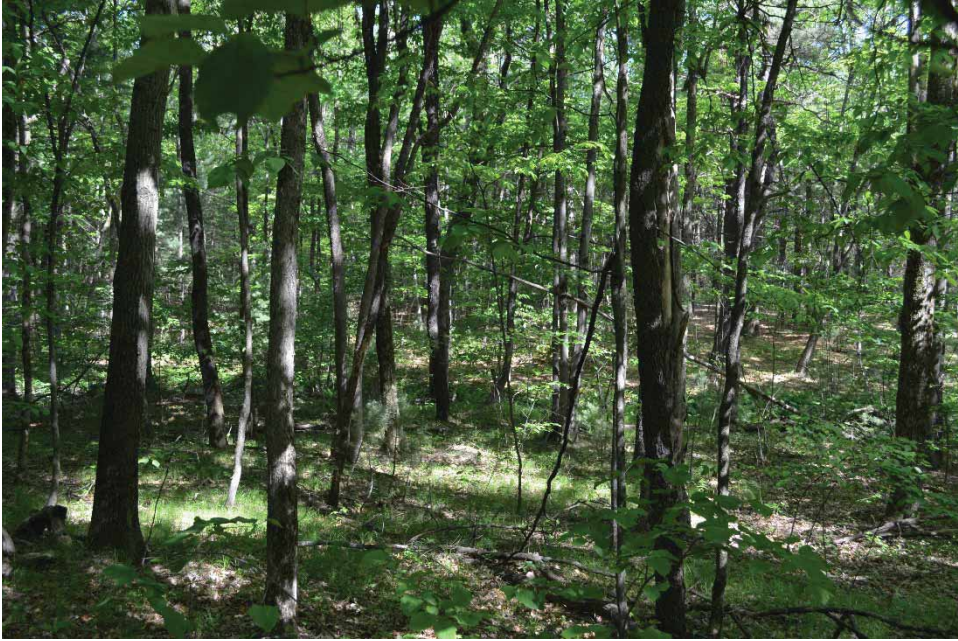
Figure 1. Deciduous (oak) forest

Deciduous (Oak) Forest (9 acres - Figure 1): This type consists primarily of scarlet oak (*Quercus coccinea*), red oak (*Quercus rubra*) and white oak (*Quercus alba*) with some red maple (*Acer rubrum*), beech (*Fagus grandifolia*), black cherry (*Prunus serotina*), eastern cottonwood (*Populus deltoidea*), quaking aspen (*P. tremuloides*), white pine (*Pinus strobus*) and hornbeam (*Carpinus caroliniana*). There are also scattered pitch pine (*Pinus rigida*) south of the wetland in the eastern portion of the forest as well as a patch of sugar maple (*Acer saccharum*) in that area. The shrub layer is limited and primarily witch hazel (*Hamamelis virginiana*), though I found lowbush blueberry (*Vaccinium angustifolium*) and maple-leave viburnum (*Viburnum acerifolium*) scattered about. There are scattered seedlings, with white pine and oak (likely scarlet oak) seedlings generally being the most abundant. There are also scattered seedlings of witch hazel and very widely scattered oriental bittersweet (*Celastrus orbiculatus*). There are few saplings (trees greater than 1-2 m) though oak saplings can be found along portions of the trails. There is extensive cover of Canada-mayflower (*Maianthemum canadense*), starflower (*Lysimachia borealis*), patches of Pennsylvania sedge (*Carex pensylvanica*), patches of partidge berry (*Mitchella repens*), dense patches of hay-scented fern (*Dennstaedtia punctilobula*) and scattered wintergreen (*Gaultheria procumbens*), goldthread (*Coptis trifolia*), fringed milkwort (*Polygala paucifolia*), New York fern (*Thelypteris noveboracensis*) whorled wood aster (*Oclemena acuminata*), northern ground-cedar (*Diphasiastrum complanatum*). The closest type using the New York Natural Heritage Program community classification would be Appalachian oak-hickory forest, which is a broad type with a lot of variation, though hickories are absent here.

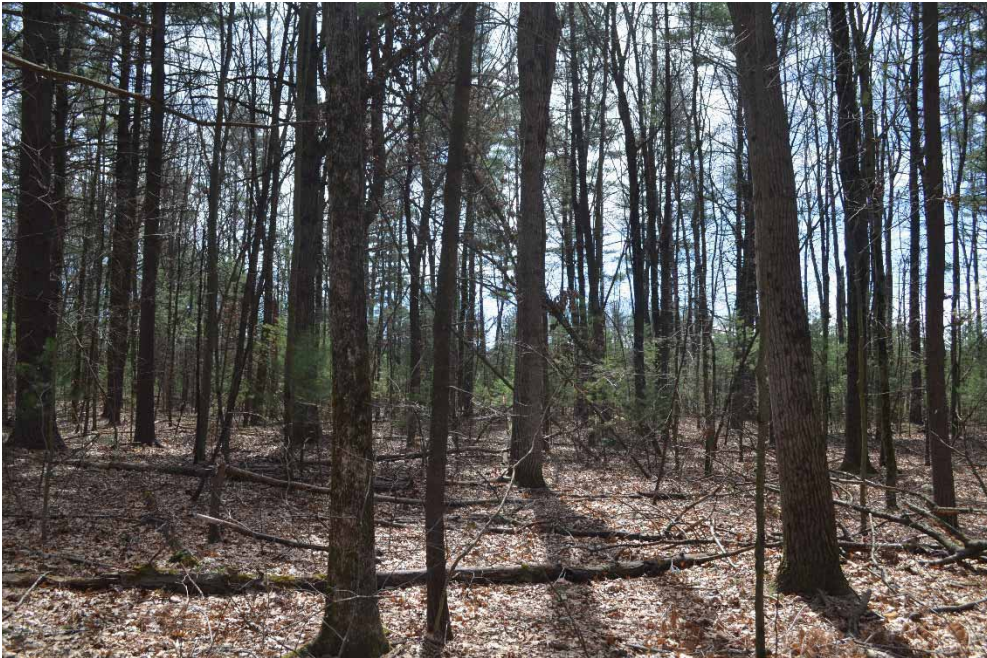
Figure 2 White pine-mixed deciduous forest

White Pine-Mixed Deciduous Forest (20.7 acres - Figure 2): This type is very similar to the deciduous forest except that white pine is also dominant in the canopy and there are numerous white pine seedlings and saplings. Wild grape (*Vitis* sp.), a vine, was also in this type. The herbaceous layer is like that of the deciduous forest. The closest New York Natural Heritage program type would be Appalachian Oak-Pine forest, which is also a broad type with a lot of variation.

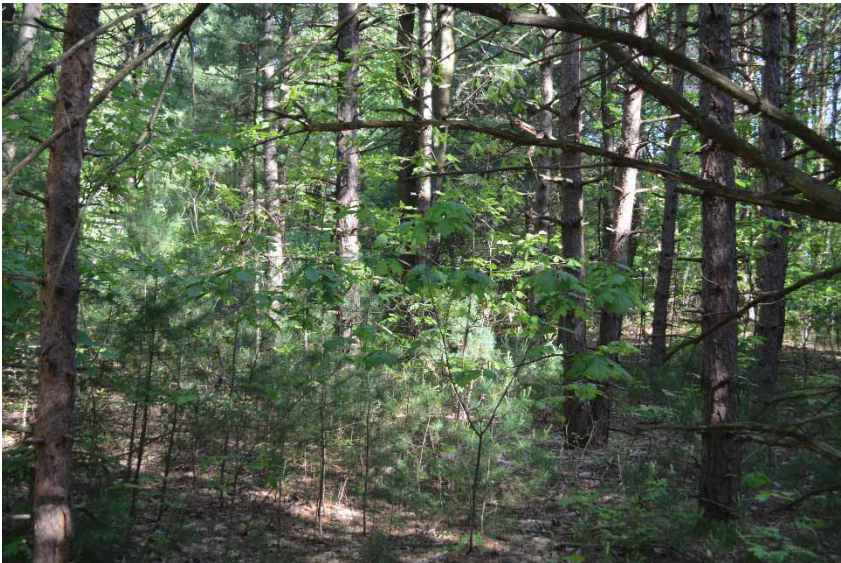
Figure 4. Northern portion of red pine plantation.

The northern part is more diverse with white pine mixed in the red pine, red oak, eastern cottonwood and red maple. Some of the oaks and white pines appear open grown so the plantation may have been planted around them. There were also some other species such as scrub oak (*Quercus ilicifolia*), gray dogwood (*Cornus racemosa*), and Virginia creeper (*Parthenocissus quinquefolia*), which is a vine on the ground. The Natural Heritage Program type the best fits is a mixture of pine plantation and successional northern hardwood forest.

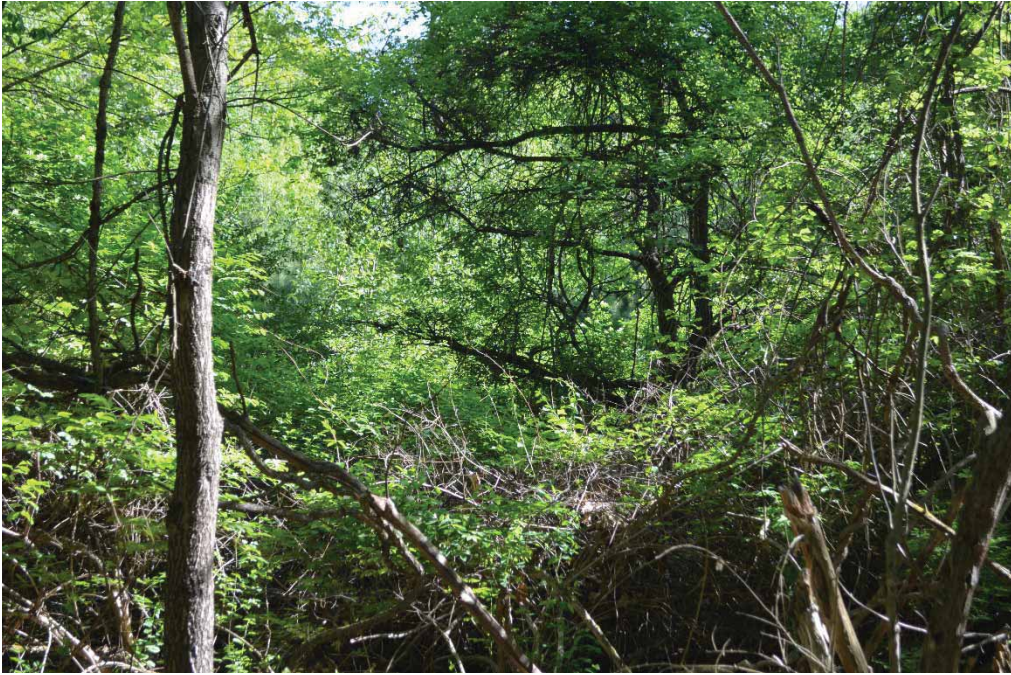
Figure 5. Successional forest/shrubland

Successional forest/shrubland (1.7 acres (Figure 5): This type contains white pine, several species of poplar (*Populus deltoides*, *P. tremuloides*), black cherry, beech, apple (*Malus* sp.); hazelnut (*Corylus* sp.) and scattered blackberry (*Rubus* sp.), are in the shrub layer and goldenrod (*Solidago* spp), butterfly weed (*Asclepias tuberosa*) and strawberry (*Fragaria*, sp.) in the herbaceous layer. Oriental bittersweet (*Celastrus orbiculatus*), bush honeysuckle (*Lonicera morrowii*), autumn olive (*Elaeagnus umbellata*), privet (*Ligustrum* sp.) are all invasive species. Oriental bittersweet was sometimes found in other cover types, but those cover types were largely free of the other invasives I listed in the successional type. Some disturbance created this successional gap in what is otherwise a small, but intact forest remnant. This would be characterized by the Natural Heritage Program as a successional northern hardwood forest.

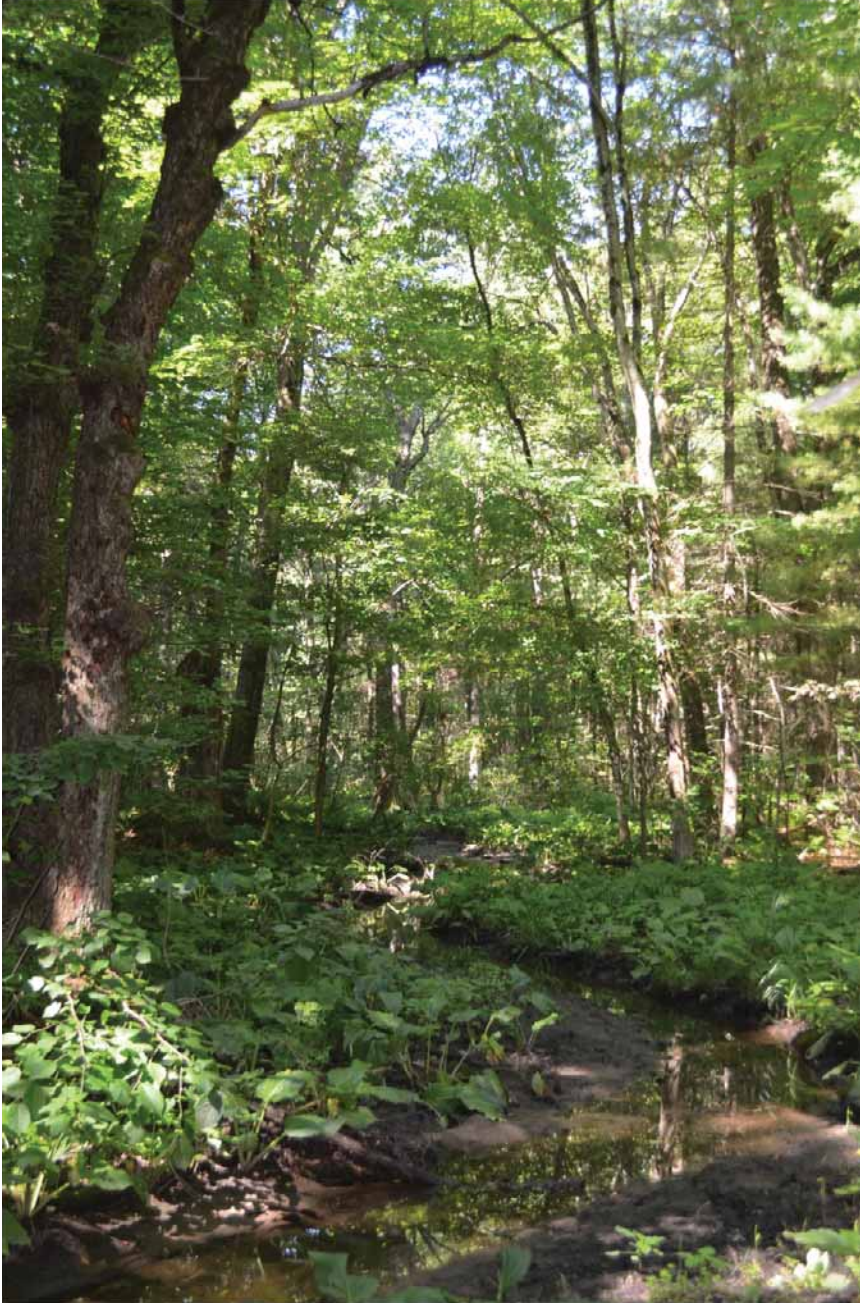
Figure 6. Wetland

Wetland (2.1 acres – Figure 6): This is a forested wetland that flows west and south toward Stony Creek and the Colonie Reservoir. Tree species are the same as adjacent forest types, though red maple is more dominant and there are occasional elm trees (*Ulmus americana*) and at least two swamp white oaks (*Quercus bicolor*). Otherwise, the wetland is relatively open with scattered highbush blueberry (*Vaccinium corymbosum*), elderberry (*Sambucus canadensis*), grey dogwood (*Cornus racemosa*), and silky dogwood (*Cornus amomum*) in the shrub layer. Skunk cabbage (*Symplocarpus foetidus*)

is the dominant herb, but there is also (touch-me-not (*Impatiens* sp.), blue-flag Iris (*Iris versicolor*), beggar ticks (*Bidens* sp.), false nettle (*Boehmeria cylindrica*), clearweed (*Pilea pumila*), fringed loosestrife (*Lysimachia ciliata*), tussock sedge, (*Carex stricta*),¹ pointed broom sedge (*Carex scoparia*), fowl manna grass (*Glyceria striata*), dark green bulrush (*Scirpus atrovirens*), cinnamon fern (*Osmundastrum cinnamomeum*), interrupted fern (*Osmunda claytoniana*) and royal fern (*Osmunda regalis*). The area directly adjacent to the wetland was diverse with windflower (*Anemone quinquefolia*), jack-in-the-pulpit (*Arisaema triphyllum*), and May-Apple (*Podophyllum peltatum*), all three of which are generally upland species. The wetland is a relatively narrow channel, but widens to the west, especially offsite. On the west side of the existing crossing is a small stand of eastern hemlock (*Tsuga canadensis*) which could be part of the wetland. I believe this would best be characterized using the New York Natural Heritage Program classification as a shallow emergent marsh and/or red maple hardwood swamp.

In terms of a trail and crossing of the wetland, the wetland is narrow, so a crossing as far east as possible would be best, especially if it could be a bridge or boardwalk. I think a viewing platform would be good as well. Erosion control and replanting with native species following construction would be important to implement.

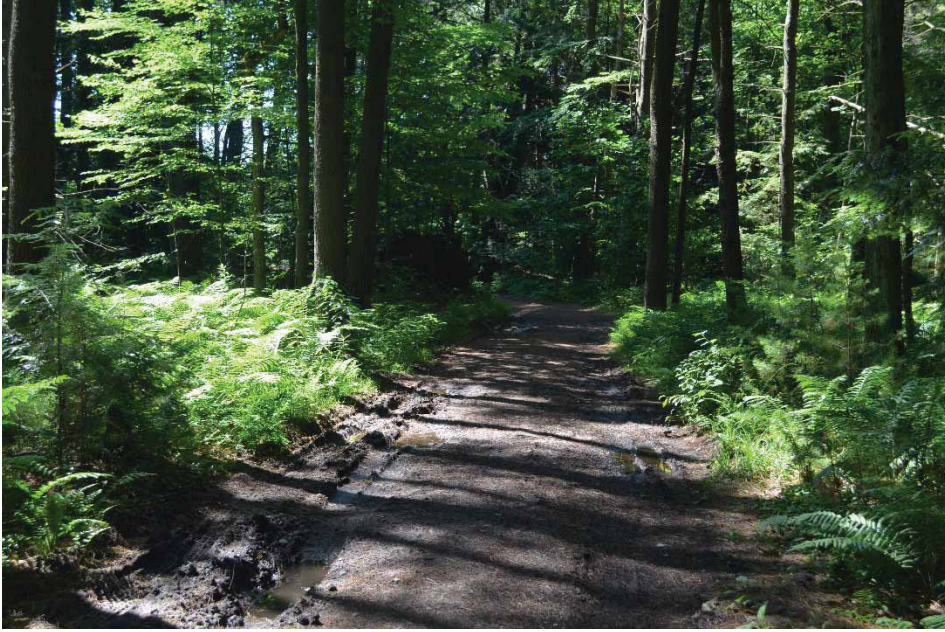
Figure 7. Wetland crossing photograph #1

As you know, there is one wetland crossing that I believe is off the property (see Figures 7 and 8). To improve that crossing would require some work on the road to prevent the soil from eroding into the wetland as you can see in the photographs below. Replacing the culvert would likely entail raising the road. The sizing would need to be such that the current hydrology of the wetland remained intact. It appears the wetland becomes relatively full in the late winter and spring and dries in the summer, depending on storm events. There was little open water during July. The crossing would need to be designed to avoid significantly increasing or decreasing these seasonal water levels, though some increase would be better than any decrease.

Another option would be a low water crossing, eliminating the culvert. That would depend on what kinds of vehicles use the crossing and how people would cross the wetland when the water level is high.
